The timber frame barn had major repair works carried out in the 1980s. Almost all of the east wall frame was removed and a crude wall comprising of steel columns faced with timber boarding was built.

clientprivate client

contract£210,910

date2010

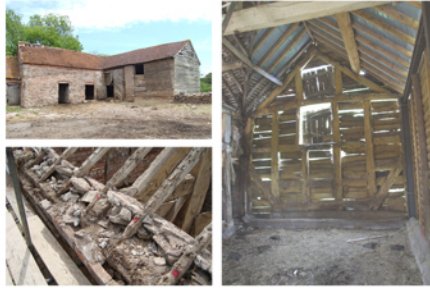
originalstate

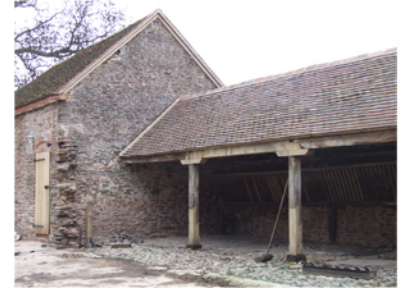
new timber frame wall

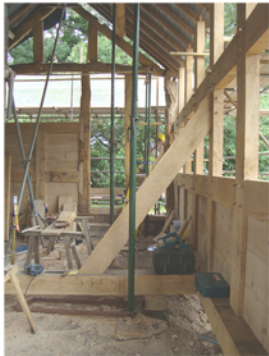
repairworks

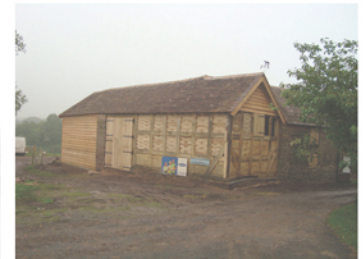
before&after

The frame survey that we carried out on the timber frame barn revealed enough information to allow us to put together a scheme of repairs and to re-introduce the traditional east frame. The client chose to reinstate the traditional timber frame scheme, and to reintroduce the traditional details that had been lost, for example:

- 1) Low level kick board infill panels above the plinths
- 2) Open wattle infill panels
