The timber frame barn had major repair works carried out in the 1980s. Almost all of the east wall frame was removed and a crude wall comprising of steel columns faced with timber boarding was built.

clientprivate client

contract£210,910

date2010

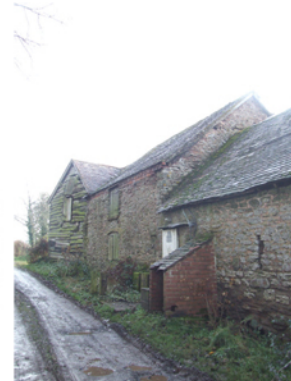
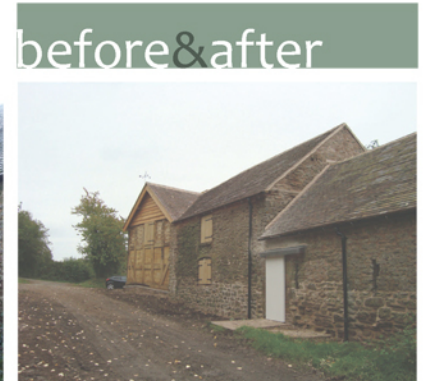
before&after

The frame survey that we carried out on the timber frame barn revealed enough information to allow us to put together a scheme of repairs and to re-introduce the traditional east frame. The client chose to reinstate the traditional timber frame scheme, and to reintroduce the traditional details that had been lost, for example:

- 1) Low level kick board infill panels above the plinths
- 2) Open wattle infill panels
