repairdetail

client St Andrew's Parochial Church Council
contract £150,000.00
date 2011

repairworks

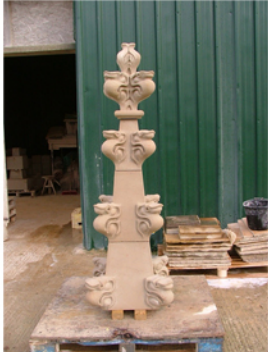
New pinnacles to replace those taken down in 1920s

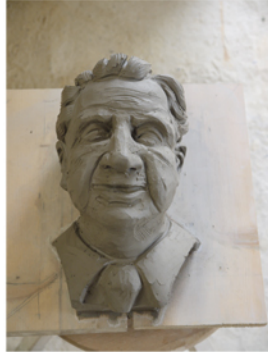
Maquette for newly carved corbel

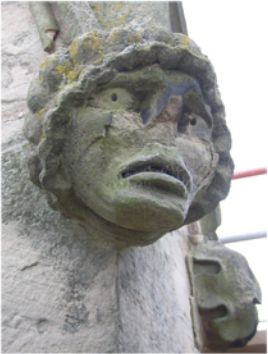
Detail of original corbelled face

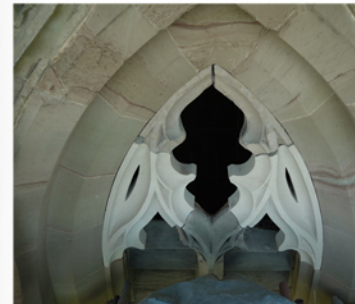
New traceried sound opening
